SURVEY-INVENTORY FORM

COMMUNITY CULTURAL RESOURCE SURVEY

1.	NAME		M M P	2786		
	Historic	Hadlock Methodist Church				
	and/or Common	Barrett House				
	LOCATION	<u> </u>	UTM References:			
2.	LOCATION		Zone Easting Northing			
	Street & Number			for publication		
	Port Hadlock, Lots 1 & 2, Block 5 - not for publication City, Town					
	Hadlock	- vicinity	y of			
	State		Coun	ty erson		
	Washington		Jen i	erzon

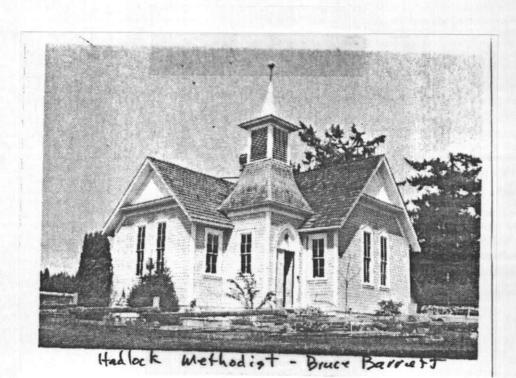
HADLOCK METHODIST CH. TZGLI RIW

The church, or now converted house, is a steeply gabled wood stucture forming an L-shape. In the corner of the L is the steeple that rises above the roof line. Entrance to the stucture is through the bottom portion of the steeple. Immediately upon entrance to the structure, straight ahead was the Sunday school room now converted into the kitchen. To the right upon entrance, is the main hall for the congregation. To the rear of the building was another rear entrance where an outhouse once was located nearby.

The old church has now been converted into a living residence. The structural quality of the building has remained virtually unchanged. Only the interior of the building has been altered in any way. Here on the inside, a sleeping loft has been built. Originally the building had high ceilings and could have been considered a 1½ story structure.
